Manhole Inspection Summary

Manhole # S15Q__025MH

Insp Date: **4/7/08 2:56 PM**

Location Address: **913 cole st**

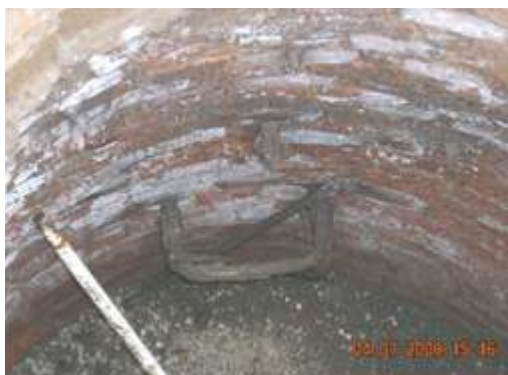
Defect 2

Steps Count: **1** Missing: **2** ☒ **Corroded**

corroded and missing steps

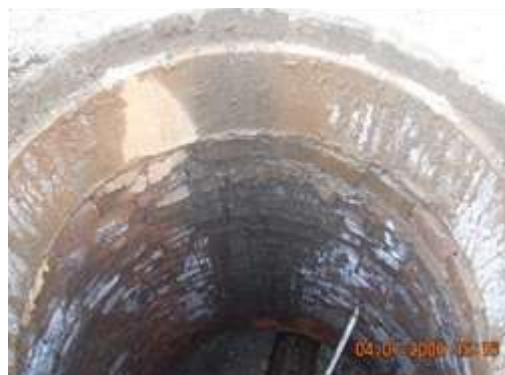
Defect 1

Condition: ☐ Sound ☐ Cracked ☐ Root Intrusion ☒ **Loose Brick** ☐ Deteriorated

Infiltration: ☐ None ☒ **Joint** ☐ Cracks ☐ Mortar ☐ Roots ☐ Wall

loose bricks in corbel, inflow evidence,
infiltration @ corbel/frame joint

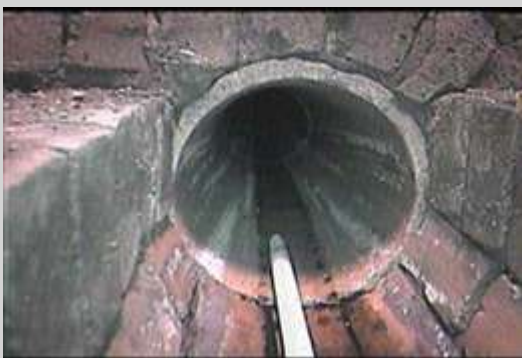
6 O'Clock Inflow

Pipe Height: **8.4** (in.) Rod and Bar (Angled)
Pipe Material: **Clay** ☐ Pipe Lined
Invert Depth: **7.20** (ft.) Flow Characteristics: **Slow**
Deposits: ☐ None ☐ Mud ☐ Sludge ☒ **Debris** ☐ Grease
Silt Depth: **1** (in.) Deposits Extent: **Light**
Infiltration: **None** Pipe Seal Cond: **Sound**
